DAMAGE ON DEEP, MULTI-TIED-BACK EXCAVATION DUE TO DEFORMATION OF THE ANCHOR-SOIL BLOCK SYSTEM

Despite the knowledge and experiences accumulated, and the available standards on the deformation behavior of multi-tied-back excavations, a damage had occurred on a deep excavation in 1994. The paper tries to reveal the source of the failure using analytical and finite element methods. It also presents the deformations and damages that had been recorded.

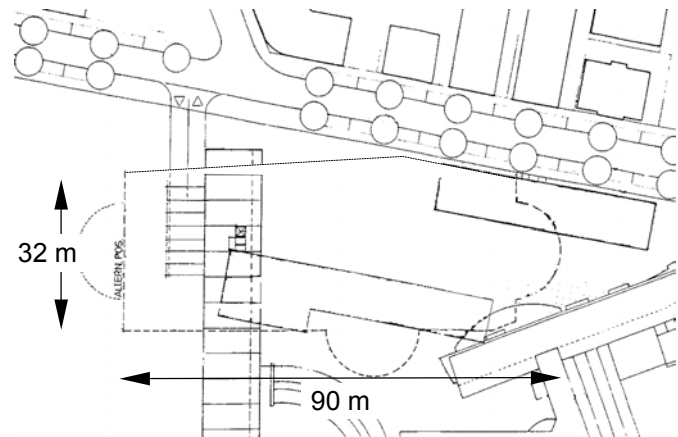
The excavation site is located in south Germany. It was intended for underground parking of the multi-storey shopping center, and completed in 1994. The site plan is shown in Figure 1. The excavation, shown in hidden lines on the site plan, was about 14.5 m deep and covered an area of 90 m by 32 m. It was separated from the existing buildings by a road. The average distance between the excavation and the existing building was about 18 m.

Figure 1 : The site plan.

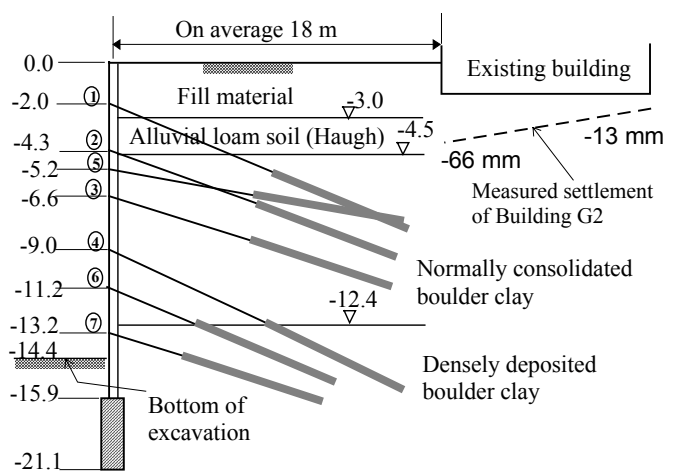
The site was investigated using numerous bore holes, sounding tests, and ground water observation bore holes. The investigation revealed a ground comprising about 3 m of fill material, overlying an alluvial loam soil (haugh) of thickness about 1.5 m. Beneath is a young glacial boulder clay of thickness about 9 m, overlying densely deposited glacial boulder clay. The soil layers are shown in Figure 2, and the corresponding soil parameters are given later in the paper in Table 2.

Because a damage on the nearby structures had already been occurred during the first excavation phase, the design had been revised during the construction for the second time in order to minimize further damages. The change of design include two additional ground anchors: one between the 2nd and 3rd anchors and instead of the 5th anchor further two anchors with change of position and inclination of the original 5th anchor were proposed. The final arrangements of the anchors and the wall are shown in Figure 2.

Figure 2 : Soil profile, Wall and anchor arrangements, and the measured settlement profile of the building.

After the fourth excavation stage and the 4th anchor had been installed and prestressed, the damage had increased considerably. It was at this time that additional two anchors had been suggested in order to minimise further damage. The first additional anchor, named as anchor 5 in Figure 2, were installed at this stage between the 2nd and 3rd anchor after refilling the excavation up to the anchor level. The purpose of this anchor was mainly to relieve the already installed anchors during further excavations

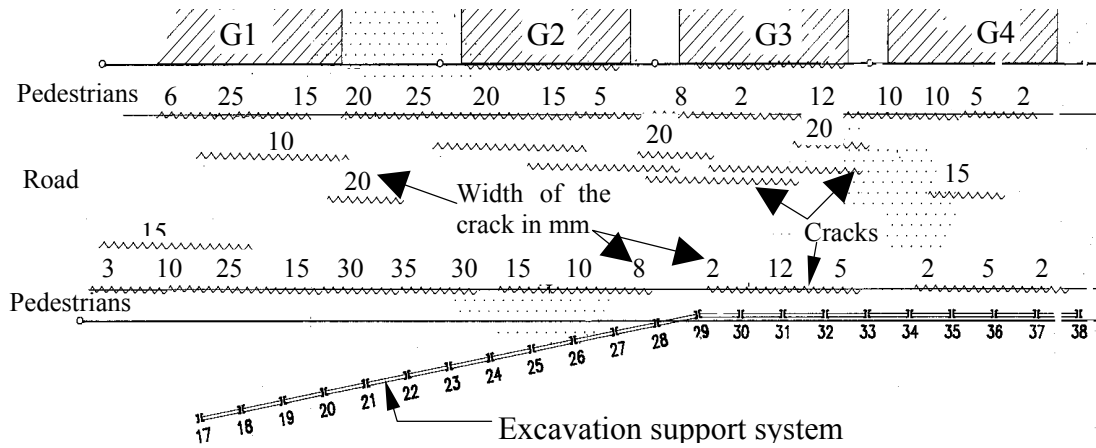
After the third anchor had been installed and prestressed (excavation depth 6.8 m), further enlarged damages had been observed in the form of a clear settlement of the surface of the road and the pedestrians way. Large cracks were seen on the surface of the road, edge of the curb stone, as well as near the existing buildings. Cracks along the entrance to the stair case and the opening to basement windows were observed. Figure 3 shows an overlook on the damage that had occurred to this time point.

Figure 3 : Observed damages and cracks in plan after the 3th excavation (-6.8 m).

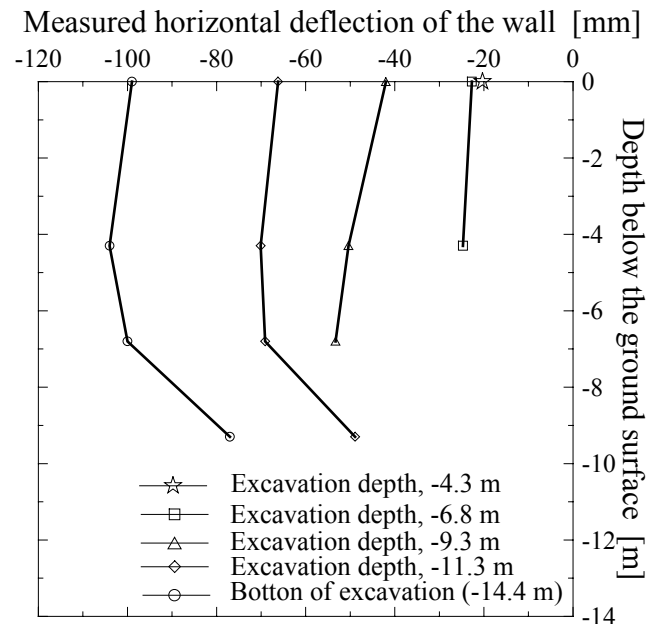
At the end of the excavation, a total settlement of 14.3 cm at the road surface, a horizontal deflection of 9.9 cm, and a vertical displacement of 4 to 8 cm at the top of the soldier pile were measured. A maximum settlement of 6.6 cm in front of the building G2 (towards the excavation) and 1.1 cm behind the building G2 were recorded. The final settlement of the building G2 is shown in Figure 2, where as the horizontal deflection of the wall at different stages are shown in Figure 4. Because the damage on the nearby structures was considerable, the case had eventually lead to court.

Figure 4 : Measured horizontal deflection of the wall at various construction stages.

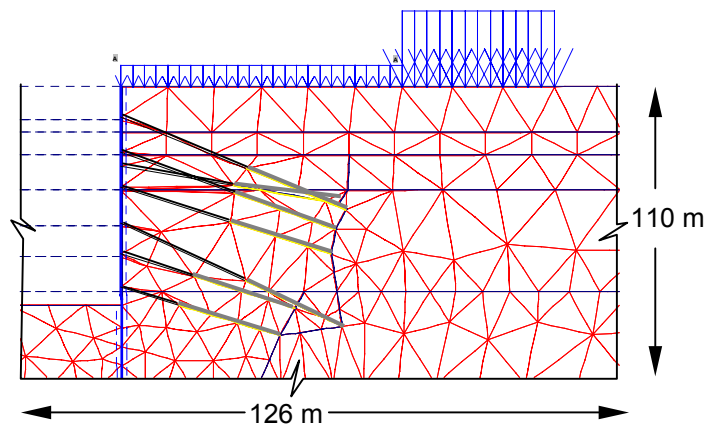
The deformation behaviour of the excavation was once more studied using the finite element method. The soil layer, the ground water, the wall, the anchors, and the construction stages were realistically modelled using the finite element computer code “PLAXIS“. A section of 110 m deep and 126 m (symmetrical) wide had been taken in the analysis and the mesh was generated using 15-node triangular elements. The upper part of the soldier pile wall with wood lagging (from top of the wall up to 1.5 m below the bottom of excavation) and the lower part are modelled as two beam elements, with two different stiffness values, rigidly fixed at their common joint. The fixed part of the anchor was modelled as geotextile. Seven excavation phase had been recognised during the construction. Each excavation phase followed by the installation and prestressing of the corresponding anchor had been realistically simulated in the program. After the 4th excavation phase had been completed and the 4th anchor had been

Figure 5 : Finite element mesh.

installed and prestressed, the excavation was refilled up to the level of the 5th anchor in order to provide a construction area for the machine to install and prestress the 5th anchor. This additional construction stage had also been included in the analysis. Part of the geometry, the mesh, the external load, and the end of excavation stage are shown in Figure 5.

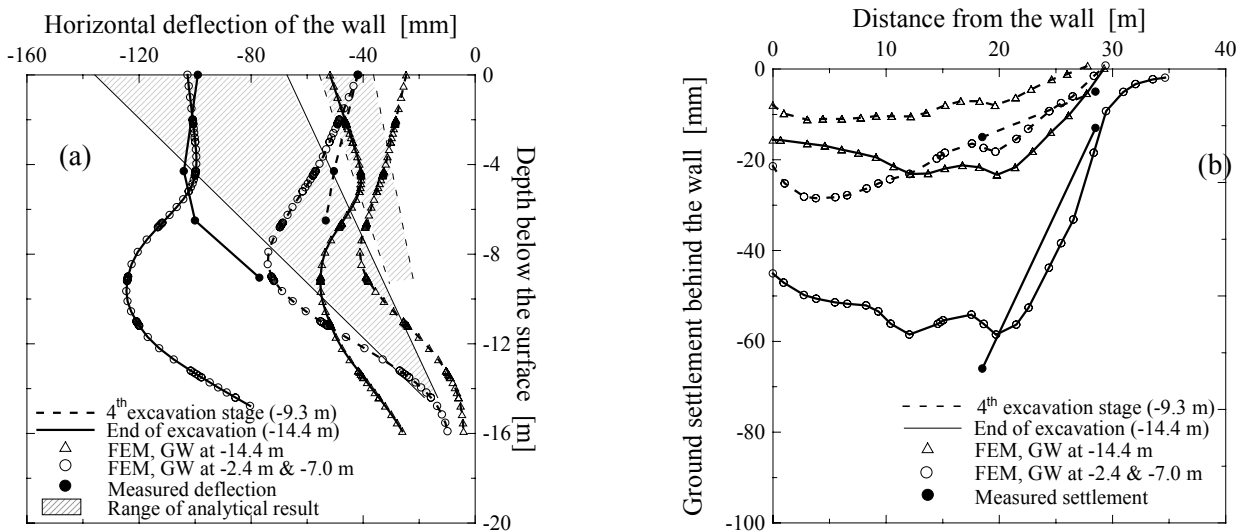
Figure 6 : a) Horizontal deflection of the wall, and b) settlement of the ground behind the wall after the 4th excavation (-9.3 m) and full excavation (-14.4 m).

The result of the finite element analysis together with the result of analytical analysis and field measured values of the horizontal deflection of the wall as well as the settlement of the near by building (G2) after the 4th excavation phase (-9.2 m) and end of excavation (-14.4 m) are shown in Figure 6. The shaded part in Figure 6a shows the region where the analytical result lies for the two extreme position of the ground water table. From Figure 6, it would appear that the horizontal deflection of the wall as well as the settlement of the ground behind the wall would had been predicted realistically with finite element and would have avoided

the damage that had been occurred. The average horizontal deflection at the top of the wall could have also been reasonable predicted using the analytical approach.

A simple parametric study on variation of the anchor length (Table 3) shows that the horizontal deflection at the top of the wall would have been reduced by 60% by increasing the anchor length by 9 m for the unfavourable GW position (i.e., GW at -2.4 m below the ground surface). Thus, the damage that had occurred would have almost been avoided.
